CONSULTANCY REPORT

**EVALUATION OF THE MICROBIOLOGICAL
QUALITY OF WATER FOR CONSUMPTION
AT THE OCEAN SKY GARMENT
MANUFACTURING FACILITIES**

**Presented by: Laboratory for Agricultural Chemistry
Services, UCA**

Date: March 15, 2011

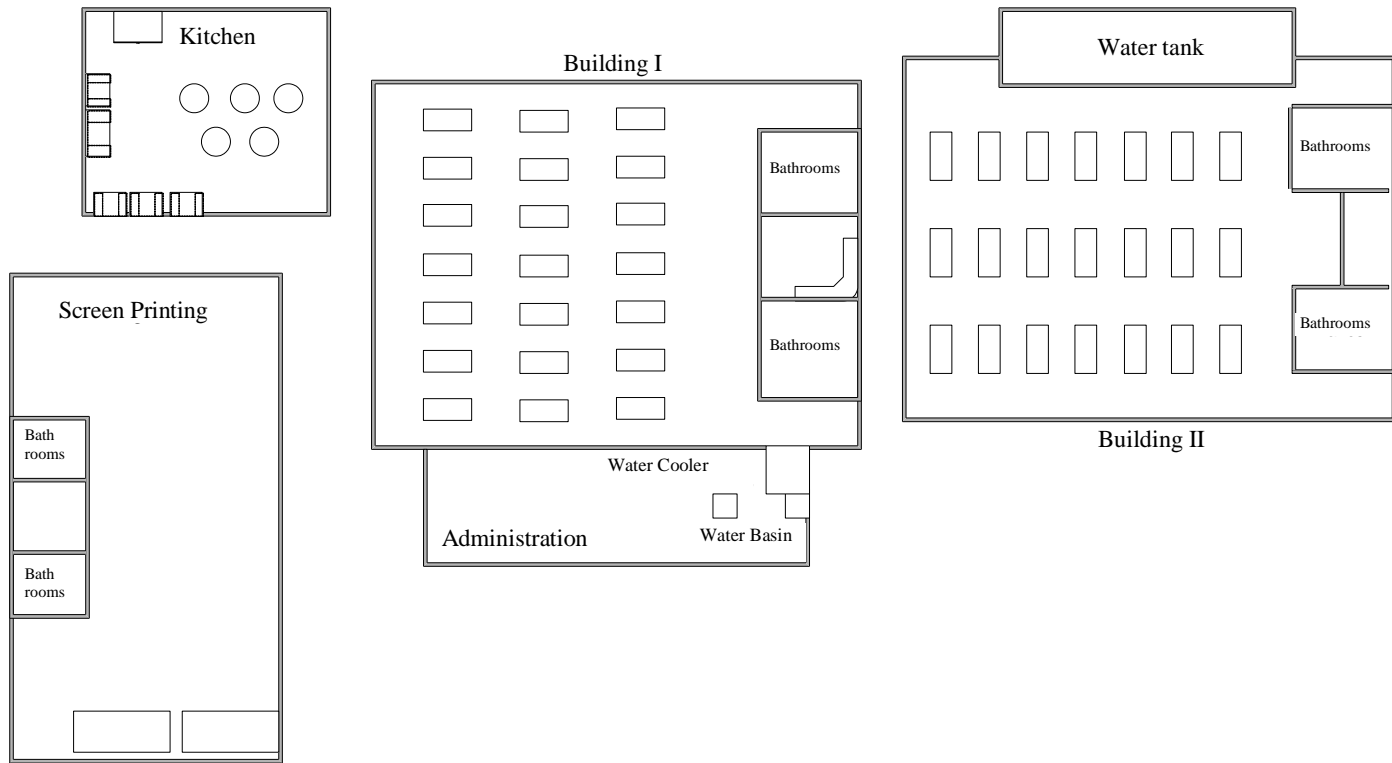
Figure 1. Floor plan for Ocean Sky plant

Ocean Sky occupies 3 plants within the International Free Zone. Building #1 houses the main production lines and the packing department. Building #2 houses the cutting department, two small production lines which produce samples and a warehouse. Building #3 (Screen printing) houses the screen printing and embroidery departments, as shown in figure 1.

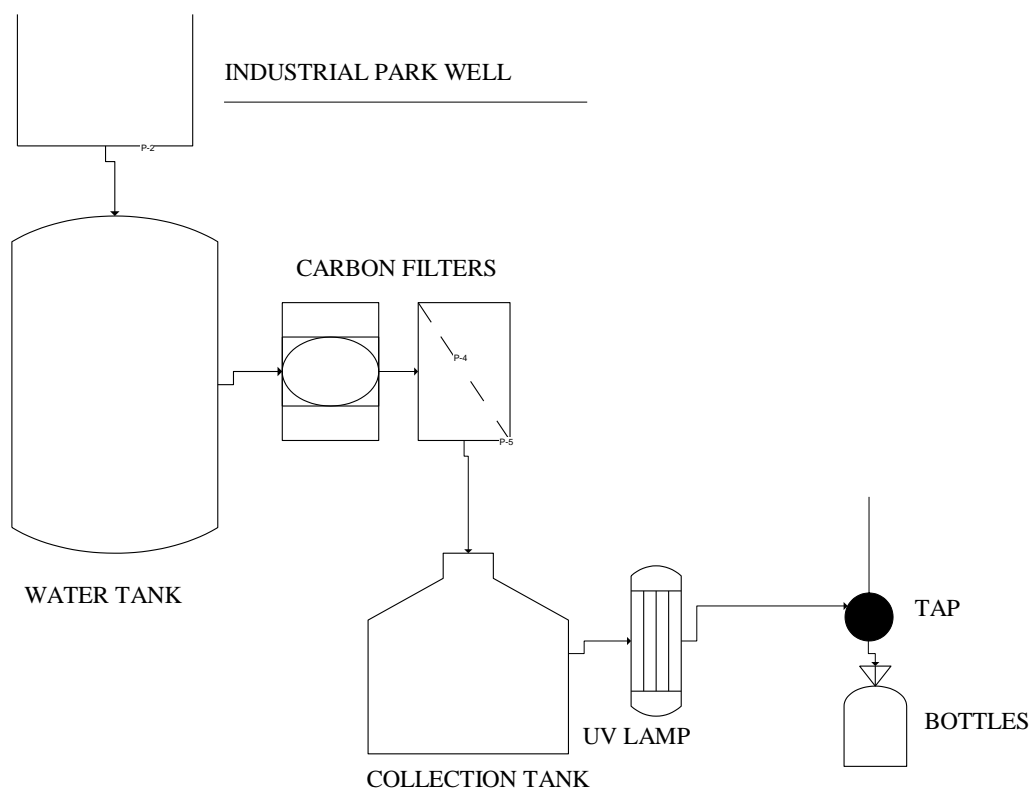
Figure 2. Water Filtration System

- 1- Building 1 y Building 2: Two areas for water filtration are found, according to the system shown in Figure 2.
- 2- In the Screen Printing and Administration areas, drinking water is supplied by commercial bottled water (*Alpina* brand) and distributed through water coolers.
- 3- The Kitchen area is supplied by Water Tank 2, and distributed through sinks. There is a single kitchen, in which meals are prepared. It has a water filter, which supplies the water used for the preparation of meals and a water basin used for washing utensils. The food service concessionaires do not prepare meals on site; they bring prepared meals and lack water systems of their own.

- 3- It is necessary to evaluate the filtration system at each point of input and output of water: before and after the carbon filter, in the water reservoir, before and after the ultraviolet lamp. In order to evaluate if the filtration system is operating adequately.

- 4- Evaluate and normalize the useful life of the filters and UV lamp used in the purification system. Likewise, it is necessary to establish the procedures for cleaning the storage tanks located after the carbon filters.

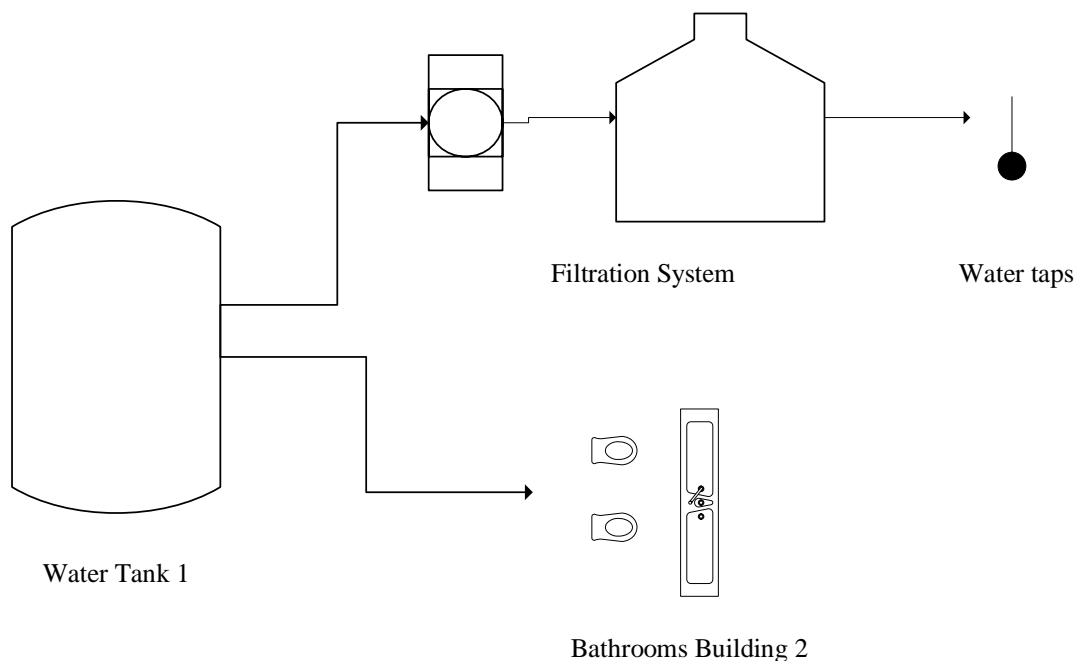
Figure 3. Distribution of water from Water Tank 1

Water Tank 1: located at the rear of building 2. The water in this tank receives a weekly chlorine treatment. This water tank feeds the filtration system for water destined for the consumption of operators. This water tank also supplies the bathrooms in Building 2.

Water Tank 1: Water from this tank is distributed as shown in figure 3, and the results are presented below, which include the temperature of the sample at the time of collection:

ANALYSIS	Total Bacteria Count (CFU /mL)	Total Coliforms (MPN /100mL)	Fecal Coliforms (MPN /100mL)	<i>Escherichia coli</i> (CFU /mL)
Water Tank 1 (29.5°C)	135 x 10 ²	Less than 1.1	Less than 1.1	Less than 1
Filtration System: Building 1 Tap 1 (29.5°C)	365 x 10 ²	Less than 1.1	Less than 1.1	Less than 1
Filtration System: Building 1 Tap 2 (29.0°C)	210 x 10 ²	Less than 1.1	Less than 1.1	Less than 1
Filtration System: Building 2 Tap 1 (28.5°C)	Greater than 300	Less than 1.1	Less than 1.11	Less than 1
Filtration System: Building 2 Tap 2 (28.5°C)	Greater than 300	Less than 1.1	Less than 1.1	Less than 1
NORMA SALVADOREÑA OBLIGATORIA (Salvadorian Mandatory Norm) NSO13.07.01:08	Less than 100	Less than 1.1	Less than 1.1	Less than 1

- 1- Verification and standardization of the procedure for cleaning Water Tank 1 and Water Tank 2: documentation and standardization, in order for it to be performed under the same conditions.

- 2- Normalize the chlorination procedure for the water tank, including the concentration of added chlorine, application method and verification of the effectiveness of the chlorination. Physicochemical controls such as residual chlorine, pH and turbidity can be established.

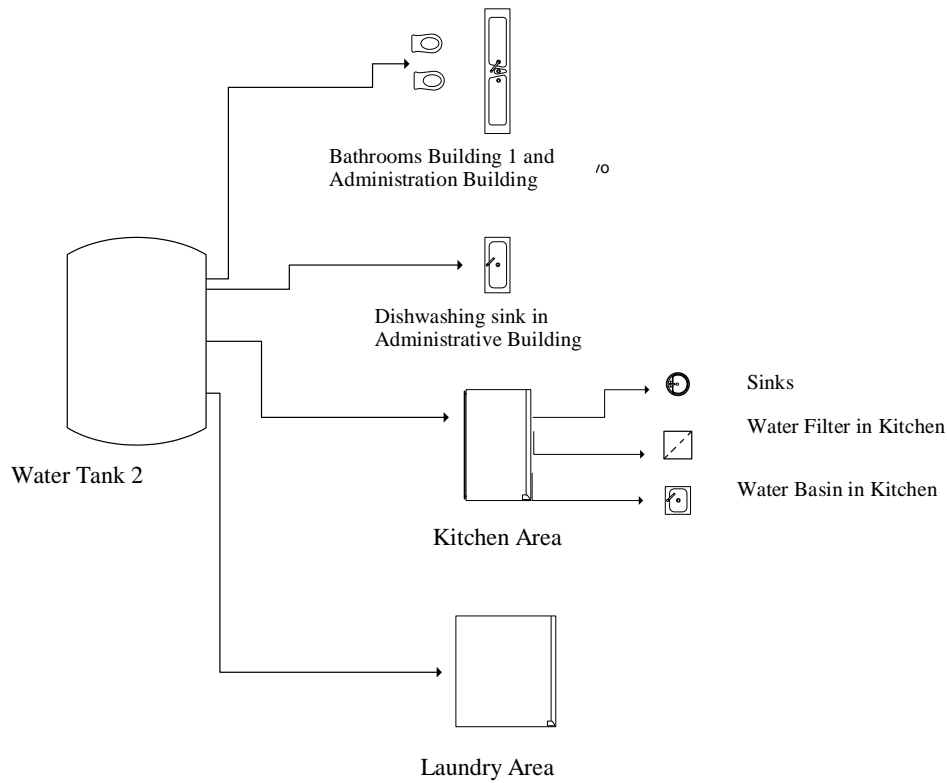
Figure 4. Distribution of water from Water Tank 2

Water Tank 2: located in the Kitchen-Cafeteria area. The water collected here does not receive treatment, because it is used for laundry and the bathrooms in Building 1 and the Administration Building. The Kitchen area is also supplied from this water tank.

Water in this tank is distributed as shown in figure 4, and the results are presented below:

ANALYSIS	Total Bacterial Count (CFU /mL)	Total Coliforms (MPN /100mL)	Fecal Coliforms (MPN /100mL)	<i>Escherichia coli</i> (CFU /mL)
Men's Bathroom Building 1 (30.0°C)	558 x 10 ²	20	20	Less than 1
Women's Bathroom Building 1 (29.0°C)	Greater than 300	20	20	Less than 1
Dishwashing sink Administration Building (29.0°C)	Less than 100	Less than 1.1	Less than 1.1	Less than 1
Kitchen area: sinks (31.0°C)	Greater than 300	20	Less than 1.1	Less than 1
Kitchen area: water filter (31.0°C)	154 x 10 ²	40	20	Less than 1
Kitchen area: water basin (32.5°C)	Greater than 300	300 x 10 ²	Less than 1.1	Less than 1
NORMA SALVADOREÑA OBLIGATORIA (Salvadorian Mandatory Norm) NSO13.07.01:08	Less than 100	Less than 1.1	Less than 1.1	Less than 1

- 5- Water entering the meal preparation area must be purified prior to entry. In addition, an industrial filter must be customized and not filters for home use such as the ones currently used.

- 7- If the water used for the bathrooms is not treated and is used to wash the worker’s bottles, it is a source of contamination for bottles and water containers, making it necessary to consider purified water for washing bottles.
